Project Name	Coastal Gaslink Pipeline Project	Inspection Status	Final
EA Certificate #	E14-03	Inspection No.	IR2021-027
Project Status	Certified	Inspection Start	2021-10-14
Sector	Energy	UTM	10U 533697 E 6071620 N
Trigger	Planned Inspection	Inspection Type	Field
Project Description	The Coastal GasLink Pipeline Project (Project) is an approximately 650 kilometer (km) long natural gas pipeline connecting facilities in northeast British Columbia (BC) to the LNG Canada facility near Kitimat.		
Location Description	The Project is near Groundbirch (40 km west of Dawson Creek) in northeast BC to the LNG Canada facility near Kitimat. This inspection covered work being carried out in Sections 1, 2 3, 4, 6, 7 and eastern 8 of the Project.		
Inspection Summary	<p>From October 14 to October 21, 2021 Environmental Assessment Office (EAO) Director of Compliance and Enforcement Chris PARKS and Senior Compliance and Enforcement Officer Clayton SMITH (collectively EAO C&E) inspected the Project against requirements of the Environmental Assessment Certificate (EAC) #E14-03 (Appendix 1).</p> <p>The Project was in Construction at the time of inspection. Project areas inspected include Sections 1, 2, 3

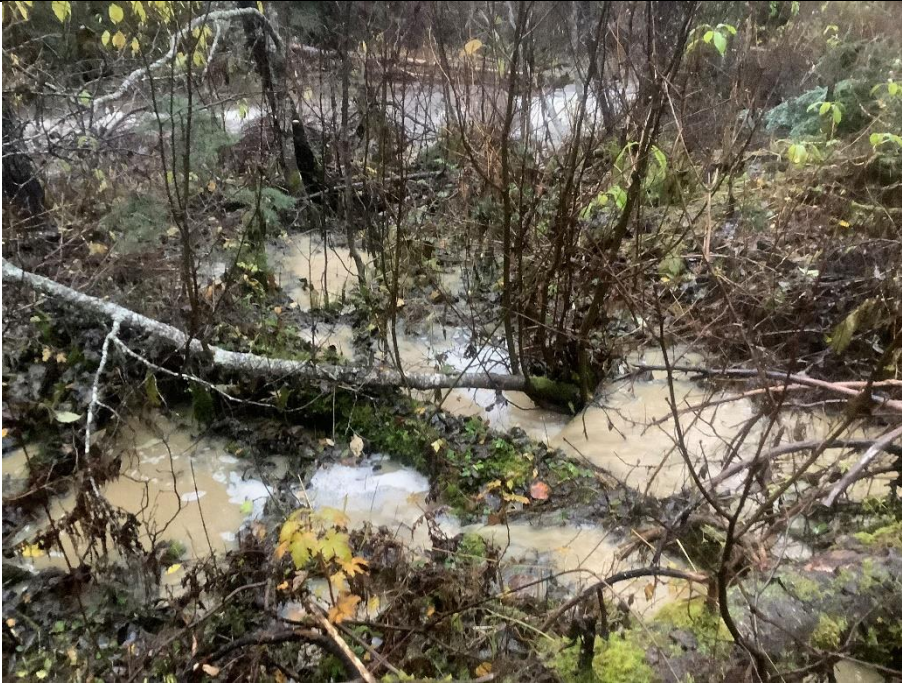
- KP180+400 –EAO C&E observed a sump being pumped down and discharging through a filter bag into an adjacent cut block. Water flows from filter bag through the cut block and to a culvert on Shoofly (SF) 12 then to a non classified drainage (NCD). The NCD flows approximately 170 m down slope and drains into an S2 (fish-bearing stream >5 – 20 m) stream feature. Evidence of sediment deposited in the vegetation up to the banks of the S2 stream was observed. Sediment laden water reached the S2 previously, as reported by the Independent Erosion and Sediment Control Auditor (IESCA) but was not actively discharging into the stream while EAO C&E was on site. On October 18, 2021 the IESCA issued an incident notification (number 129) for this site which documented Project inputs of sediment laden water into the S2 stream feature.

Photo 1. Downslope of KP180+400, sediment laden Project water reaching S2 feature (WC194). Photo taken by the IESCA on October 16, 2021.

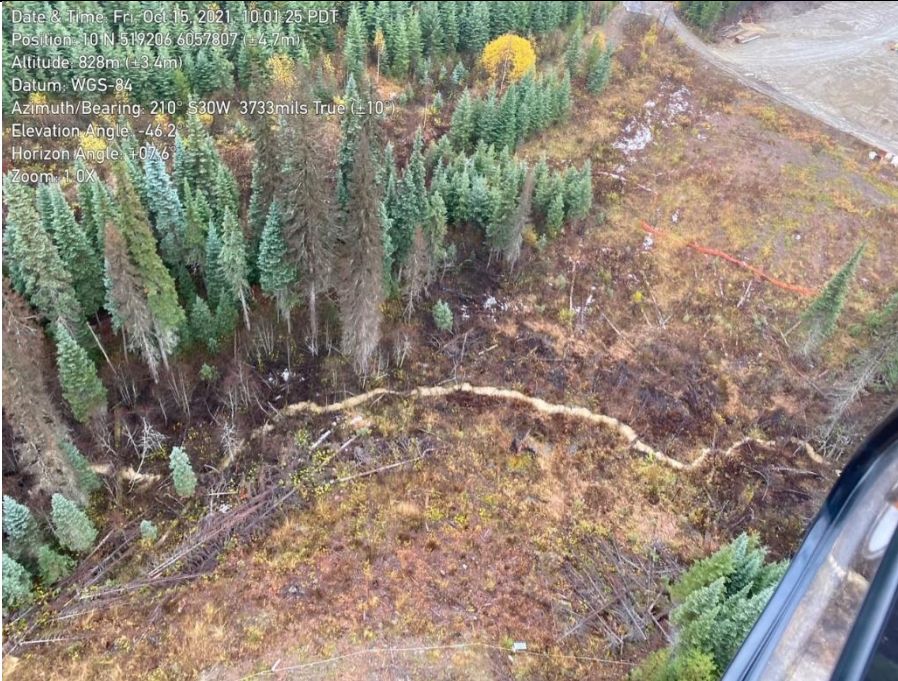
- KP208+518, (WC ID 230, S3) Tributary to the Crooked River. Observed a sump on low chain side which reports to an NCD then an S3 stream upstream of crossing. The sump was actively discharging sediment laden Project water into the channel. Erosion and sediment controls on low chain approach not maintained, effective, and/or improperly installed.

Photo 2. KP 208+518 as seen from the air on October 15, 2021.

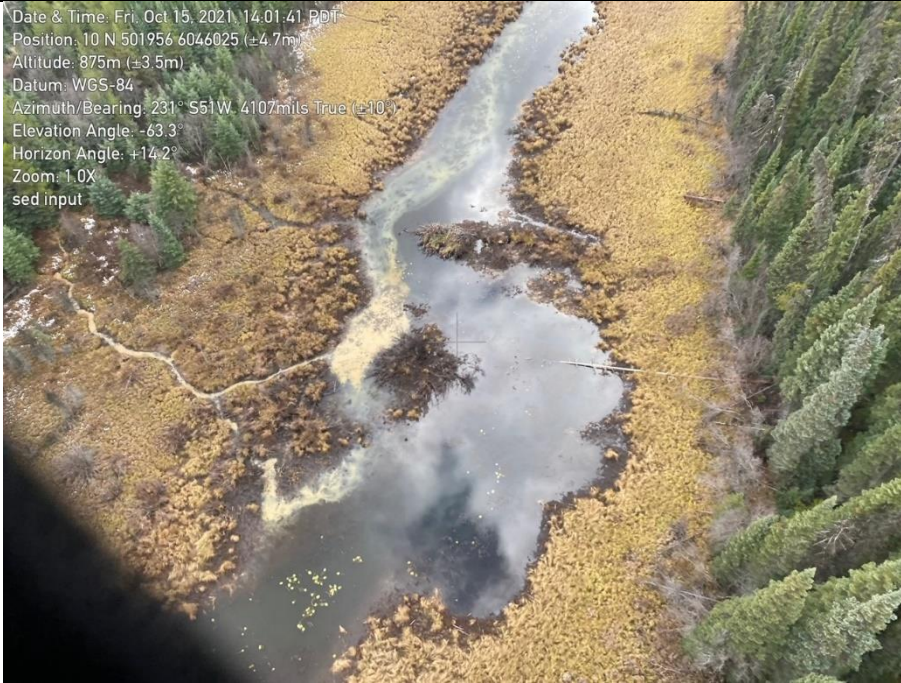
- KP231+021 – Sump on ROW discharging sediment laden Project water to a small draw / channel and flowing directly into Peculiar Creek on the low chain side of this crossing. Swale from road also directs road run off into the forest – this flow also drains into Peculiar Creek.

Photo 3. Sediment laden water from ROW reaching Peculiar Creek.

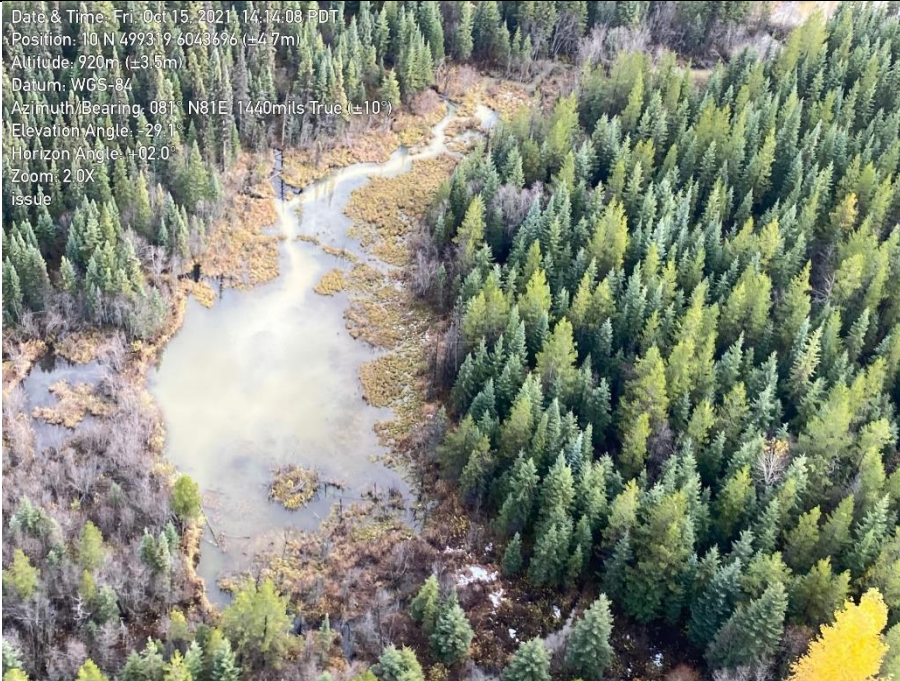
- Shoofly 23 off Davie Muskeg road (roughly KP234+500) – Sump in place on ROW with sediment laden Project water being pumped to a roadside ditch through a filter bag. Water flows down the ditch, enters a culvert and crosses the road then flows into a watercourse outside of the ROW. The stream feature was visibly turbid downstream of this crossing (approximately up to 650 m downstream) when observed from the air.

Photo 4. Sediment laden Project water observed approximately 650 m downstream of KP234+500 as see from the air October 15, 2021.

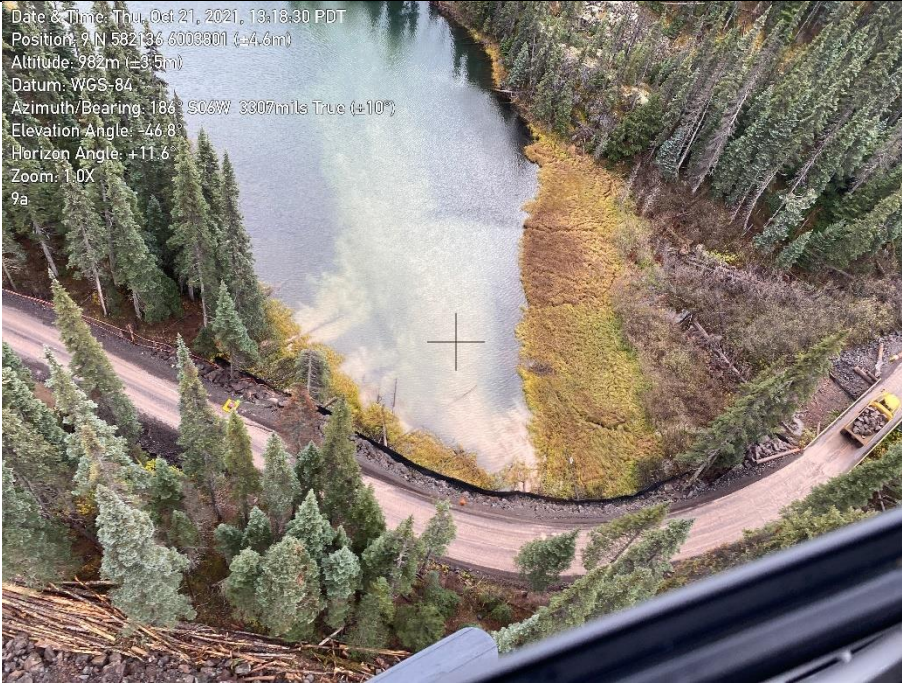
- From the air, sediment laden Project water was observed to leave the right of way and reach the Clore River in the following 5 locations (approximate KPs):
 - 601+200;
 - 603+400;
 - 603+800;
 - 604+600; and,
 - 604+820.
- From the air, sediment laden Project water was observed to leave the right of way and reach the lakes adjacent to the right of way in three separate locations between KP 586+600 to KP587+500.

Photo 5. Example of Project inputs into lakes between KP586+600 to 587+500 as seen from air.

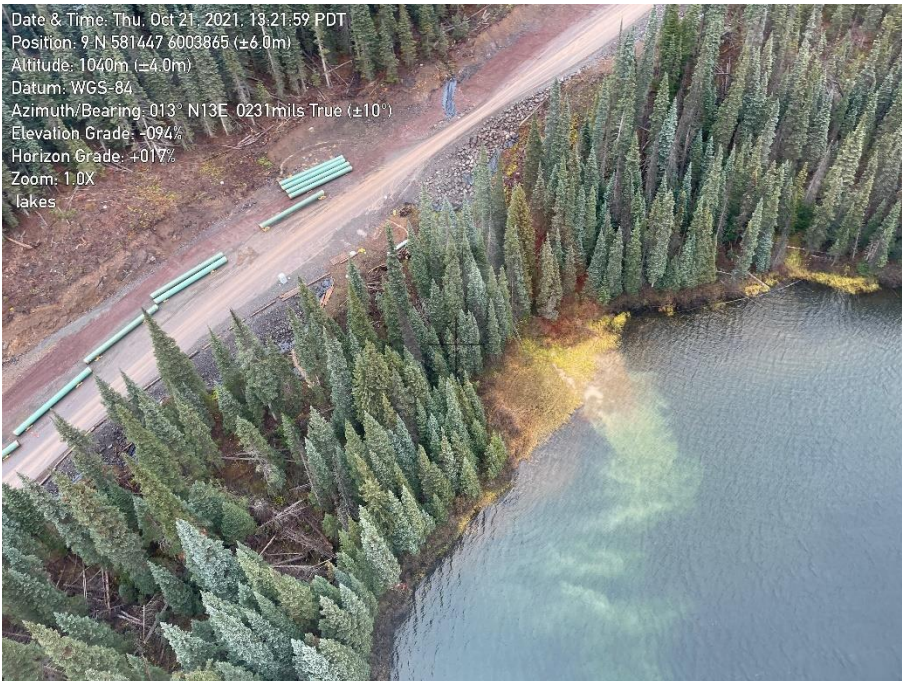
Photo 6. Example of Project inputs into lakes between KP586+600 to 587+500 as seen from air.

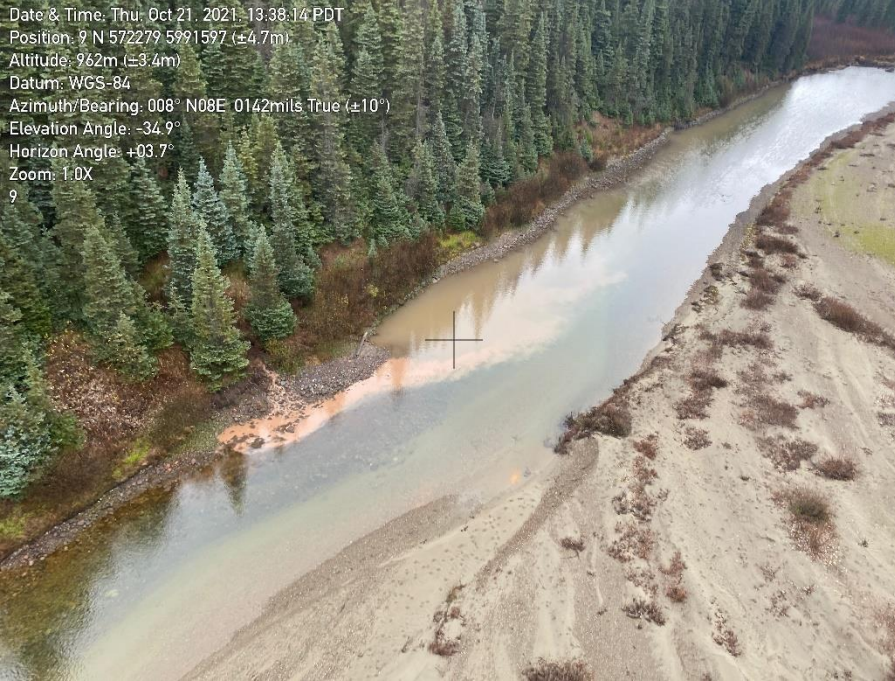
Photo 7. Example of Project inputs into the Clore River as seen from air.

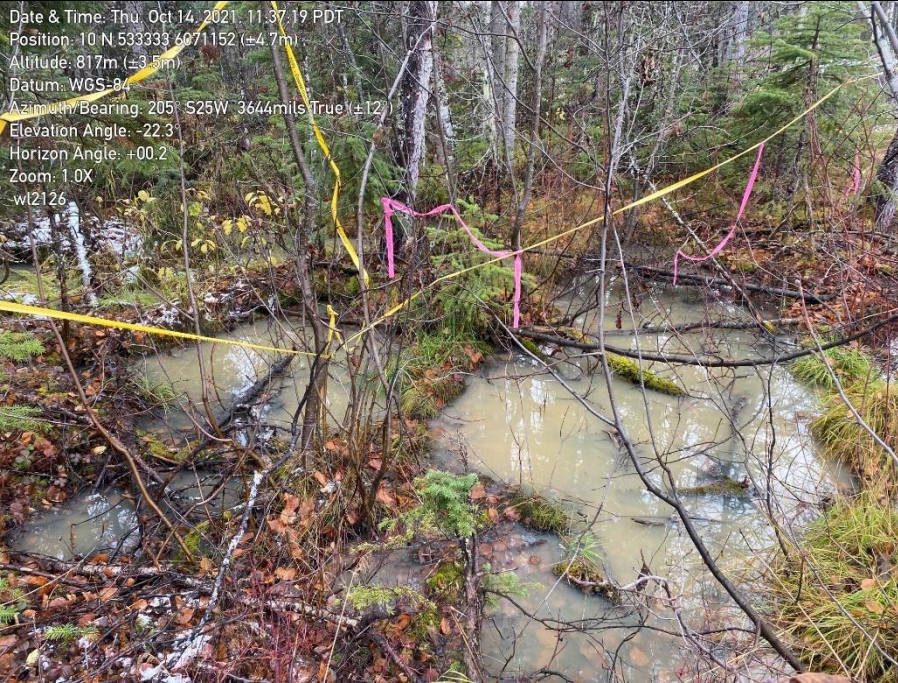
- KP 187+119 (Ecologically and Socio-Economically Important Wetland (ESIW), WL-2126). Sediment laden Project water reached ESIW and rare plant site.

Photo 8. KP187+119. Sediment laden Project water reached wetland as a result of pumping activities.

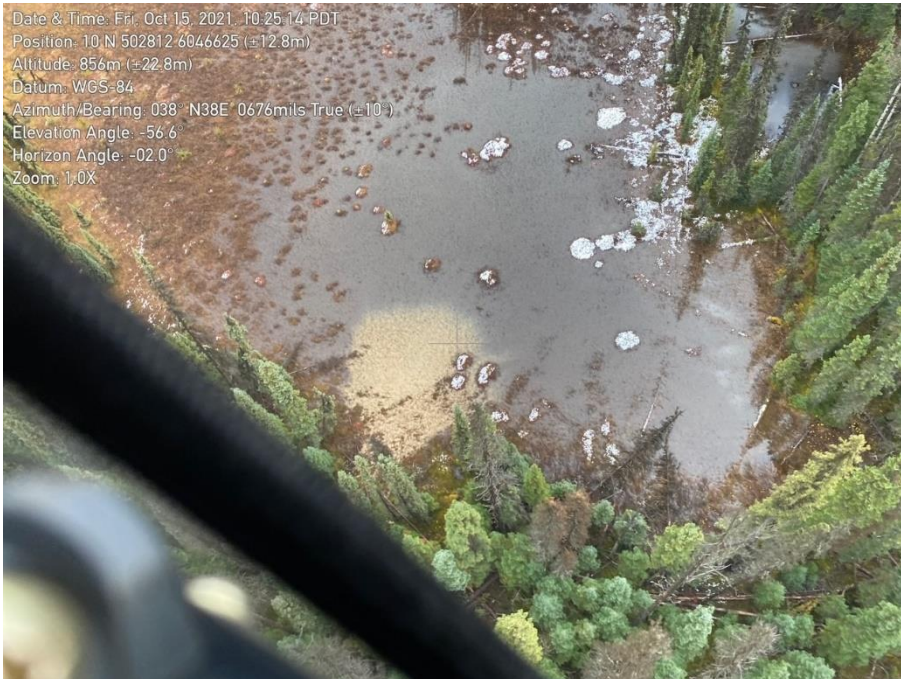
- KP 229+700 (approximately). No wetland number assigned as this feature is outside of the Project boundary. Peculiar Creek, low chain side south of ROW. Trench being dewatered through a filter bag located approximately 12 m from a wetland off ROW. Sediment laden Project water observed to be entering into the wetland with a visible plume of sediment noted in the wetland.

Photo 9. KP229+700 (approximate), wetland with sediment laden Project water flowing into it from active pumping.

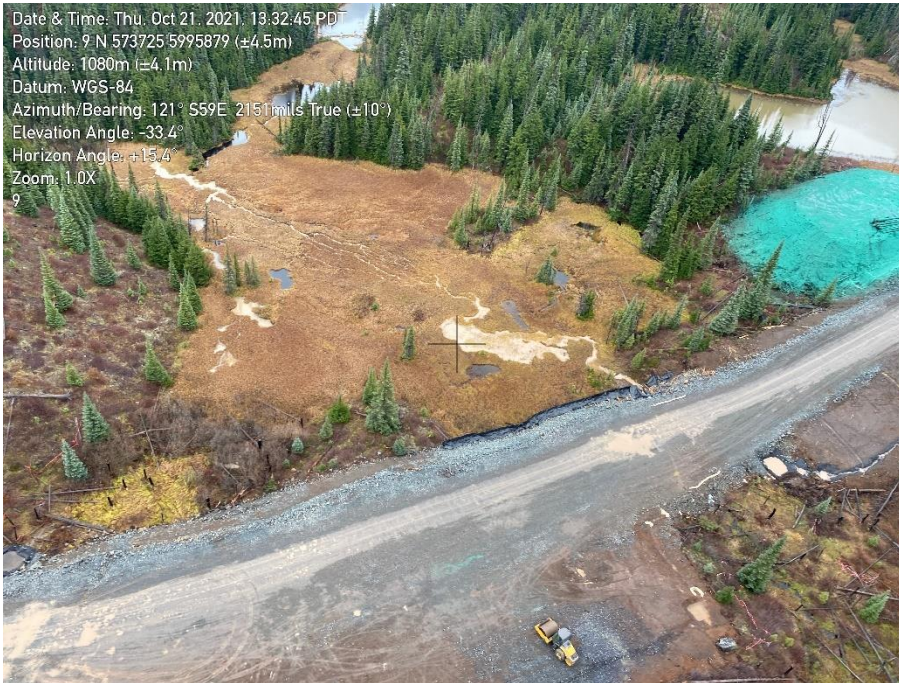
Photo 10. Near KP 600+050. Sediment laden water leaving ROW and discharging to wetlands downslope.

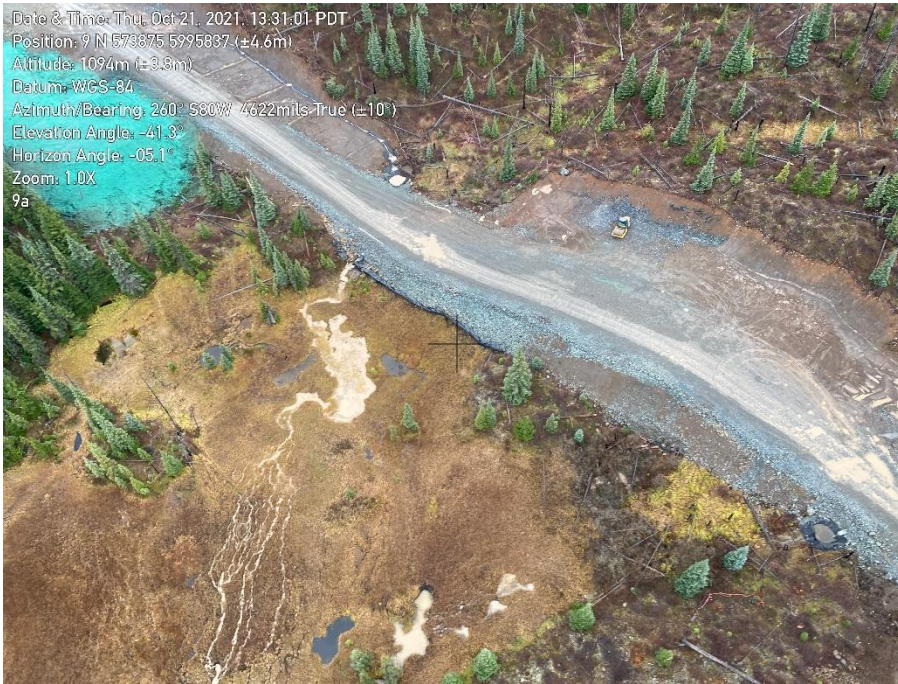
Photo 11. Near KP 600+500. Sediment laden water leaving ROW and discharging to wetlands downslope.

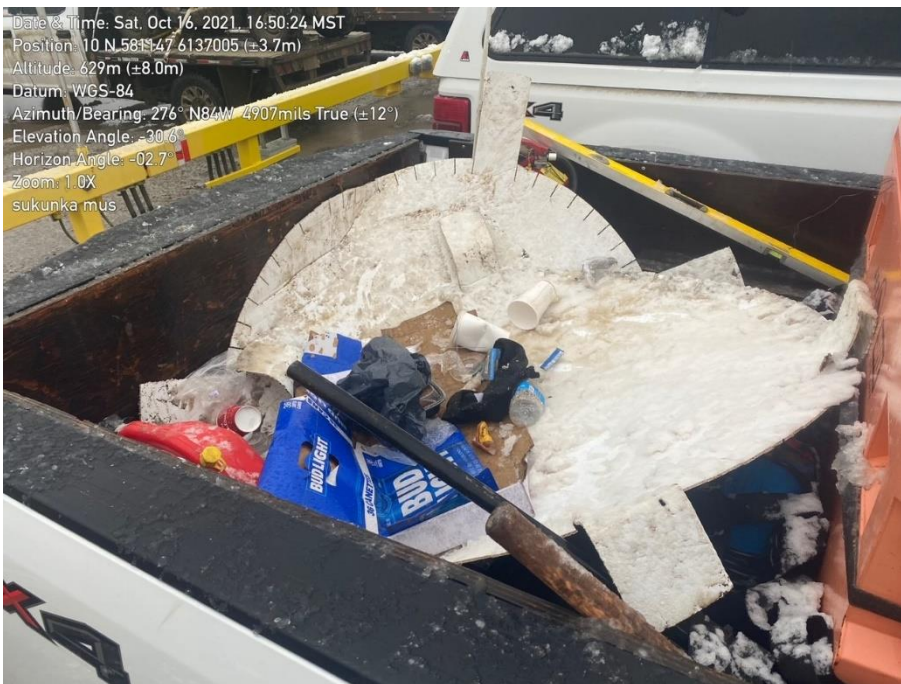
- Unsecured animal attractants with ravens accessing food waste in the back of SMJV pick-up truck and spreading throughout parking area.

Photo 12. Animal attractants stored in the back of a crew truck.

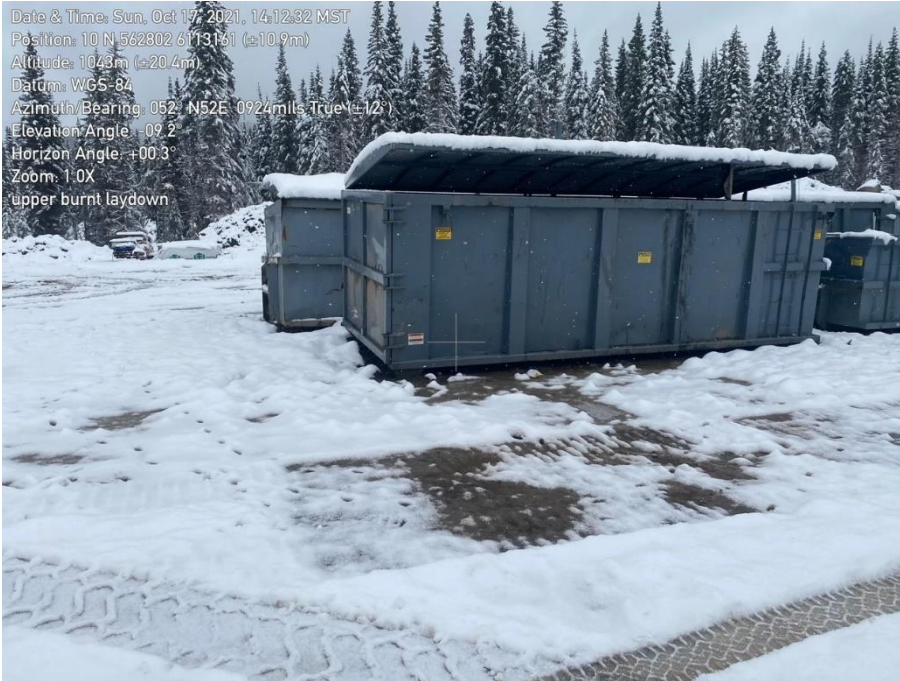
- Open waste bins with food waste stored inside accessed by wildlife. Food waste on ground animals (possibly a fox) accessing food waste pulled out of open bin as tracks were observed in the area.

Photo 13. 7.5 km laydown. Food waste bin left open.

2. Remove all anthropogenic wildlife attractants at the laydown and warehouse facility located at approximately 7.5 km on the Upper Burnt FSR (approximate UTM 10N 562803m E 6113158m N) and do not store, stage, or otherwise locate any anthropogenic wildlife attractants at this location in a manner accessible to wildlife.

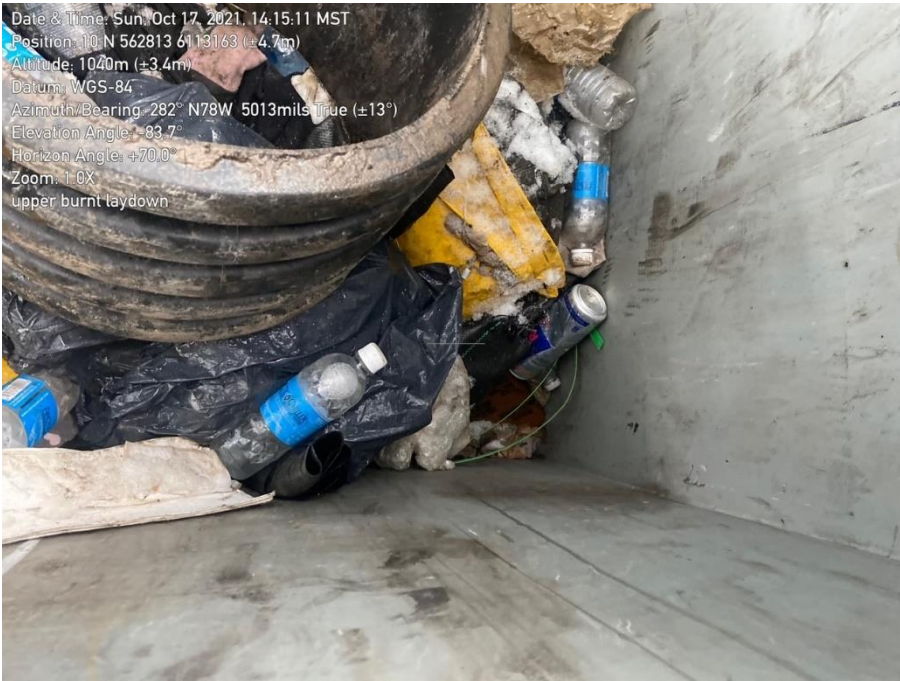
Photo 14. Example of the contents in the above bin.

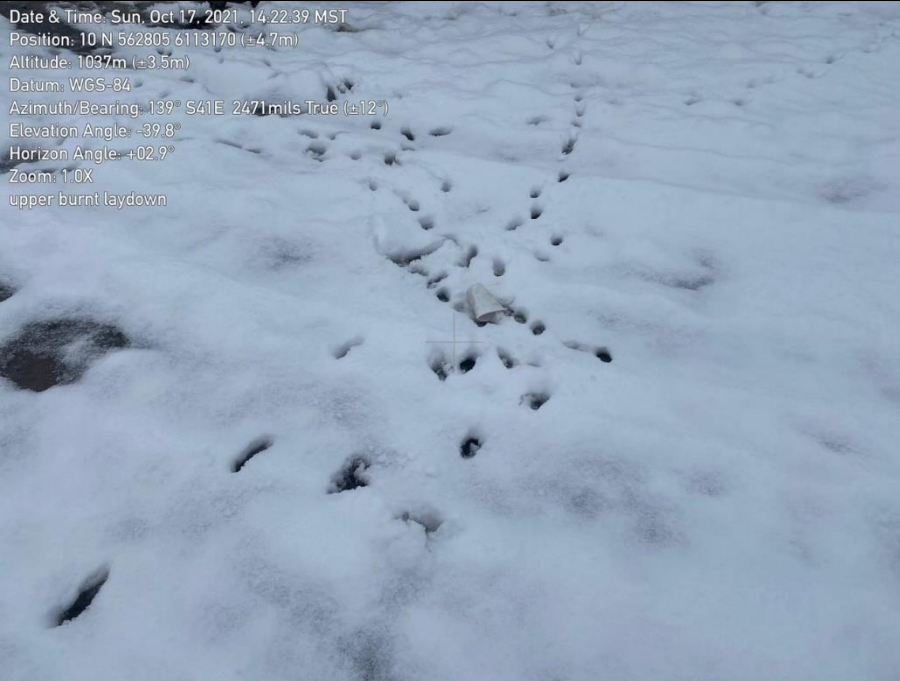
Photo 15. Wildlife tracks around food waste bins. Food waste on the ground.

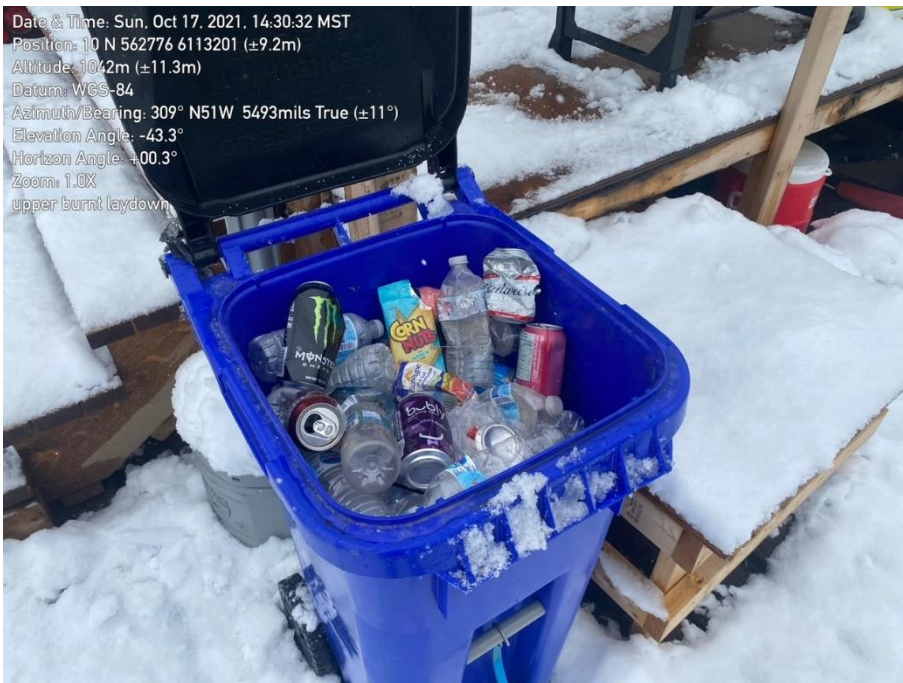
Photo 16. Animal attractants stored in non wildlife proof bin.

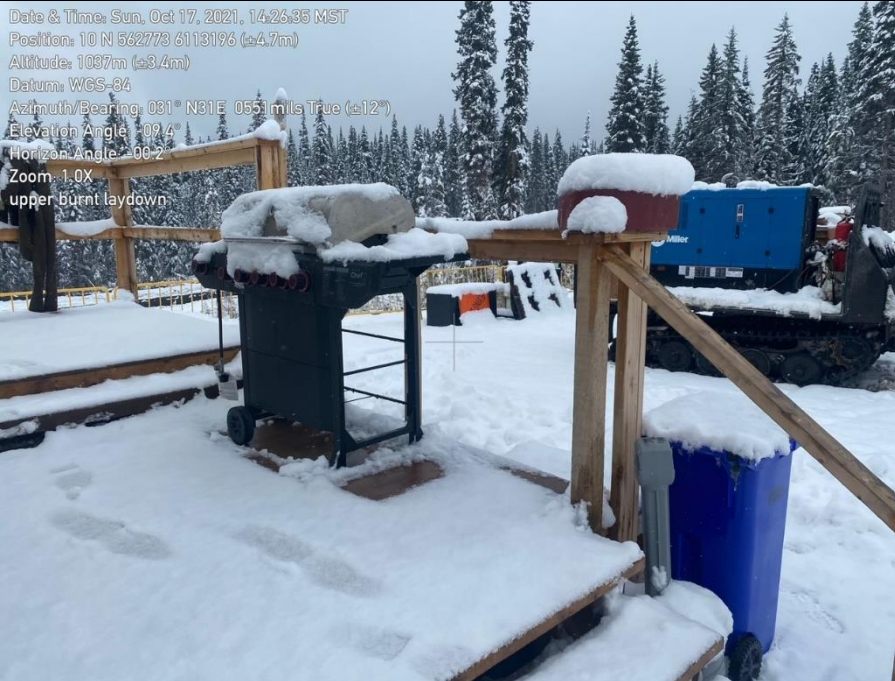
Photo 17. BBQ stored in laydown, no electric fence around this laydown.

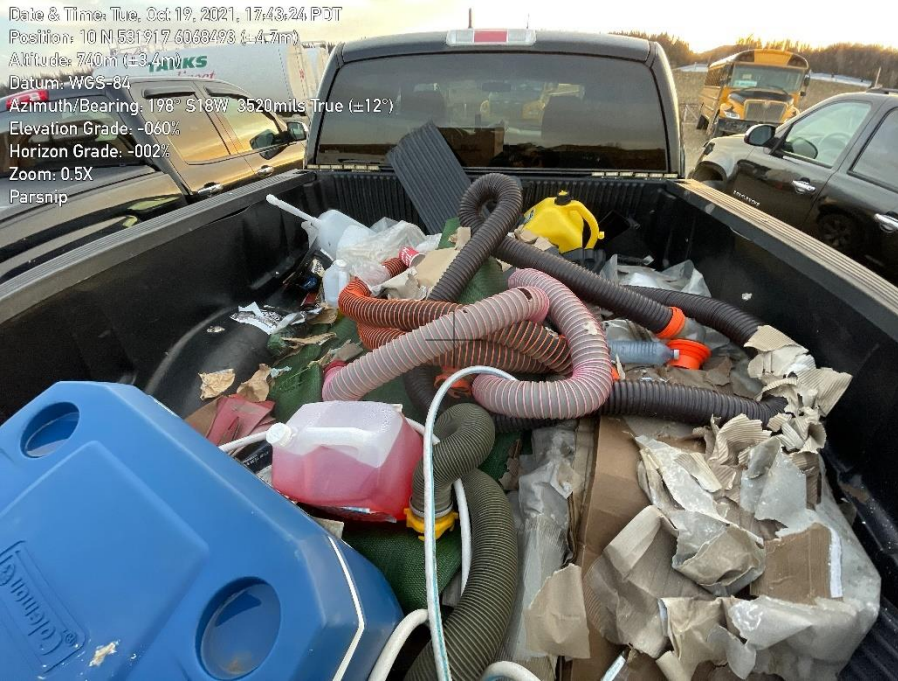
Photo 18. Waste, including animal attractants, stored in the back of a personal vehicle in the Parsnip parking area.

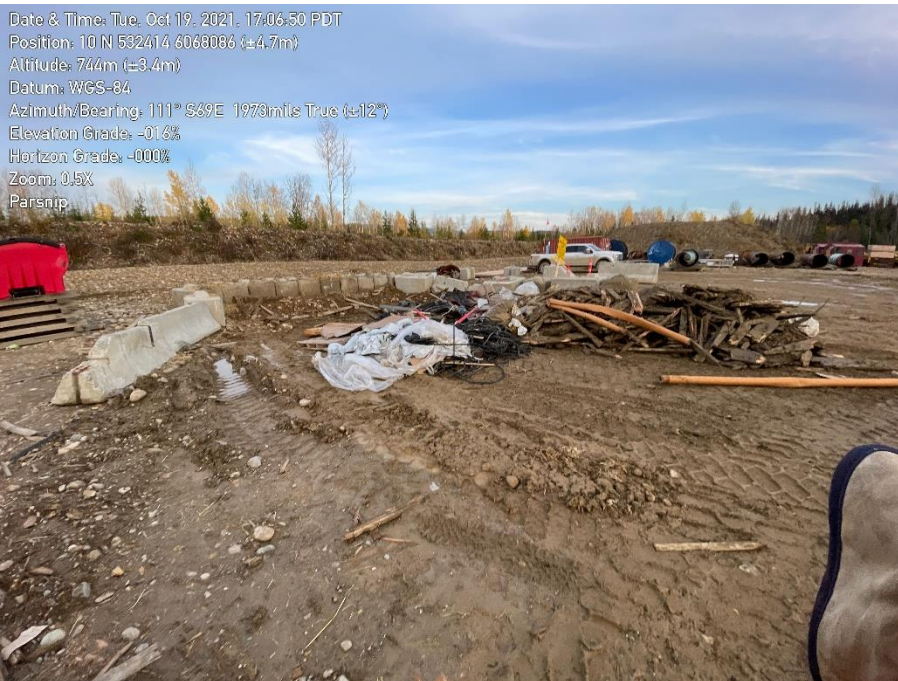
Photo 19. Mixed waste, including food waste, stored on the ground within Parsnip MUS. Signs that birds accessing this waste were observed while EAO C&E was on site.

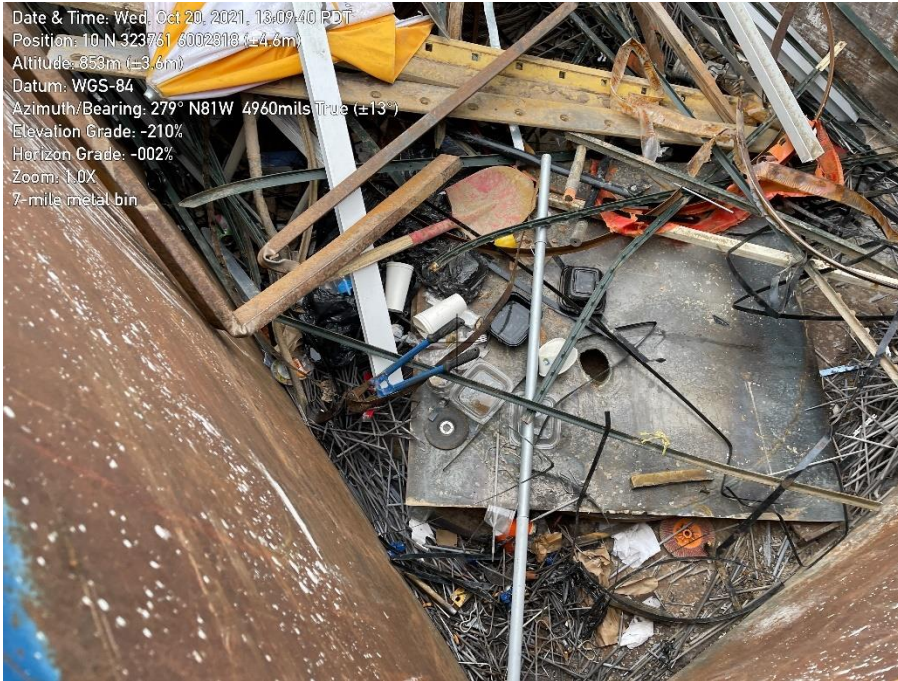
Photo 20. Bin labelled “Metal Only” found to have food waste stored within.

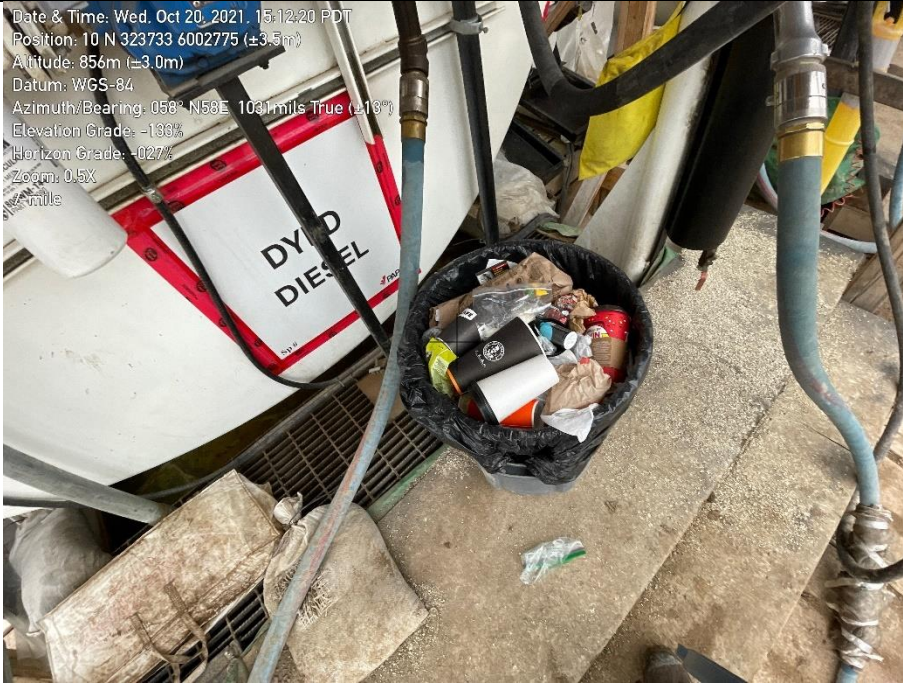
Photo 21. Non-wildlife proof bin at refueling area.

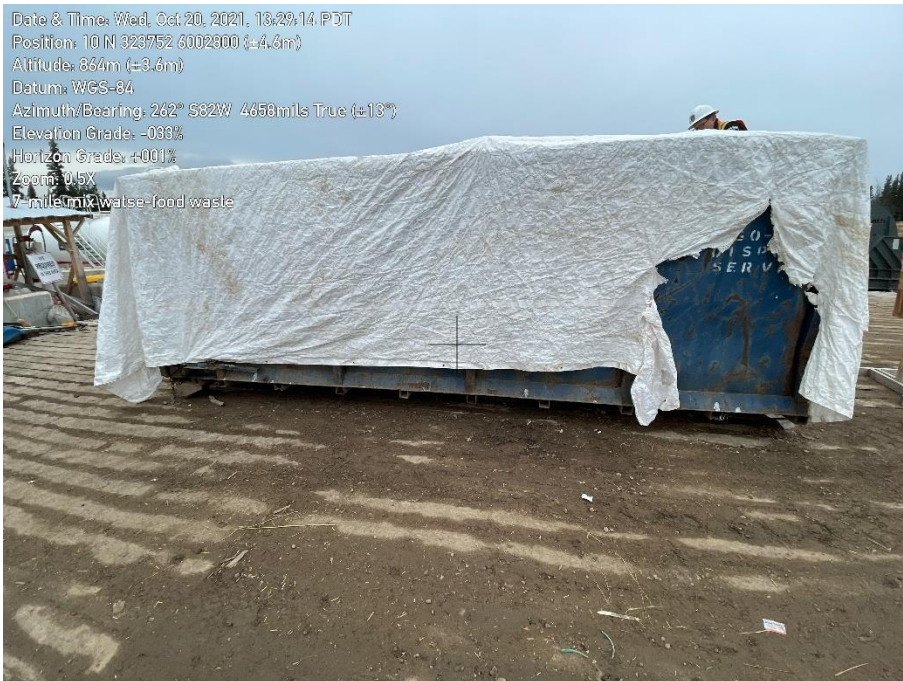
Photo 22. Non wildlife proof bin containing anthropogenic food waste.

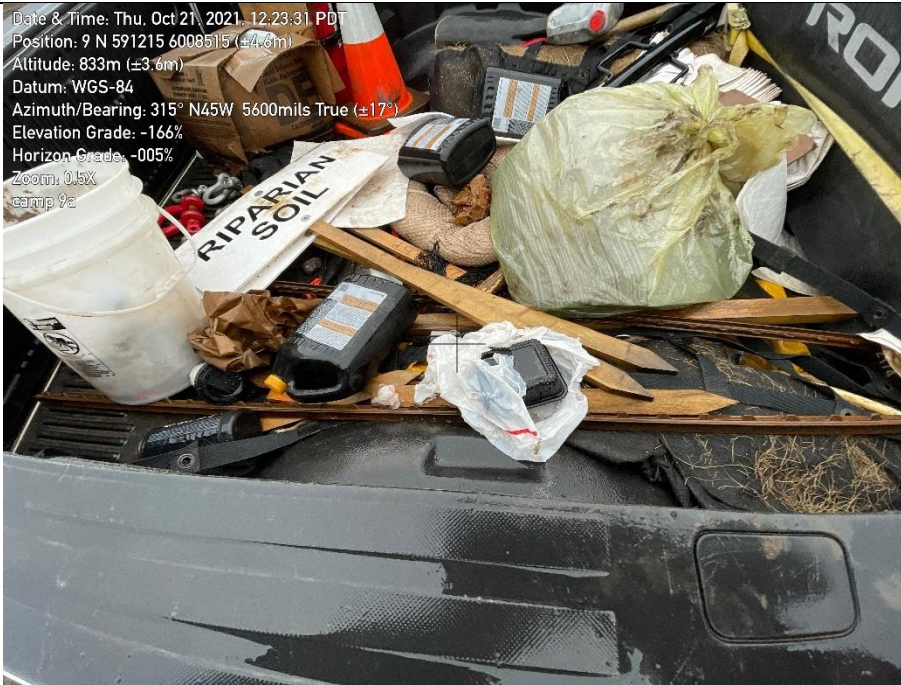
Photo 23. Food waste stored in the back of a crew truck. Signs that birds have been accessing this waste.

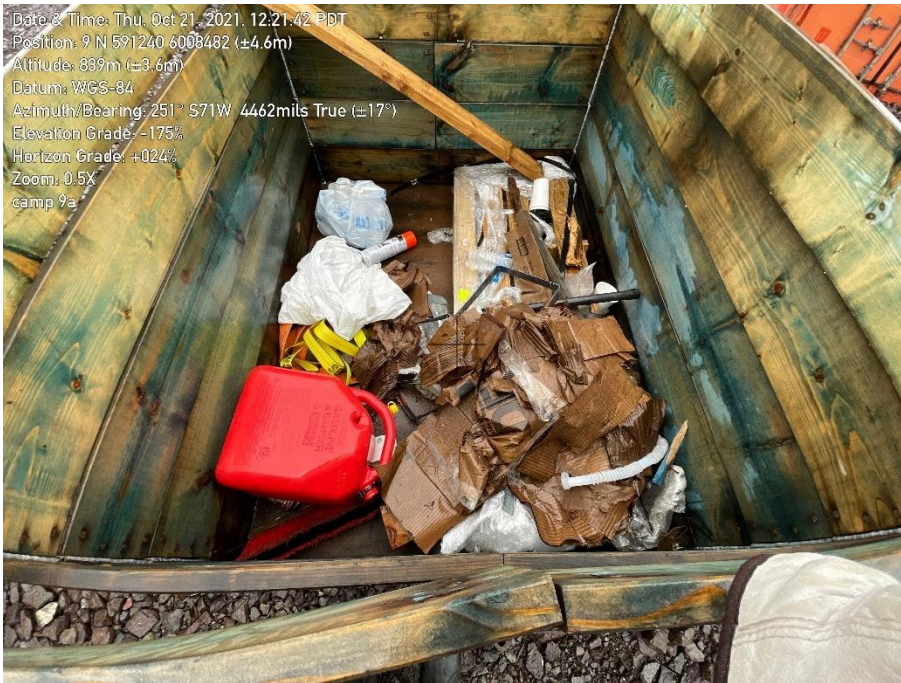
Photo 24. Non wildlife proof bin with food waste stored within.

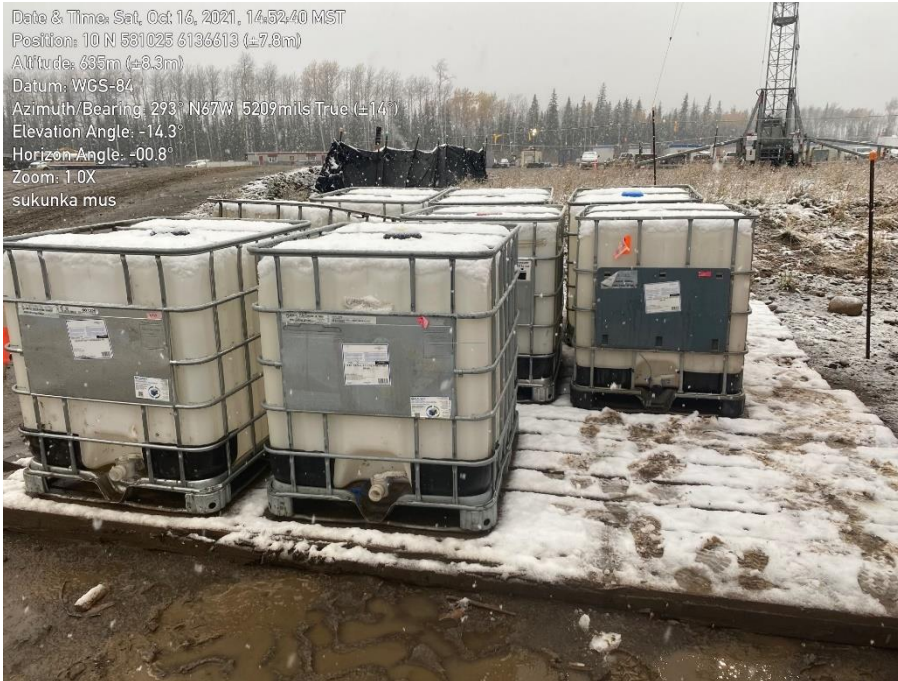
- Hydrocarbon containers (bulk containers) and other liquid chemical containers not stored in secondary containment.
- Jerry cans stored both without secondary containment and in secondary containment but on their sides.

Photo 25. Bulk containers, label indicates they contain diesel engine oil, without secondary containment at Sukunka MUS.

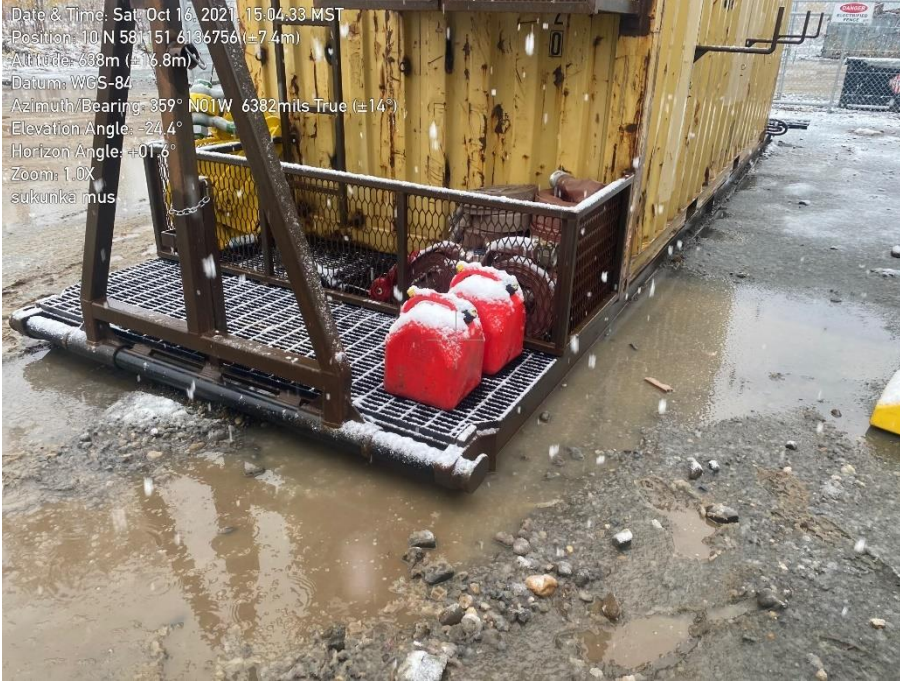
Photo 26. Jerry cans without secondary containment.

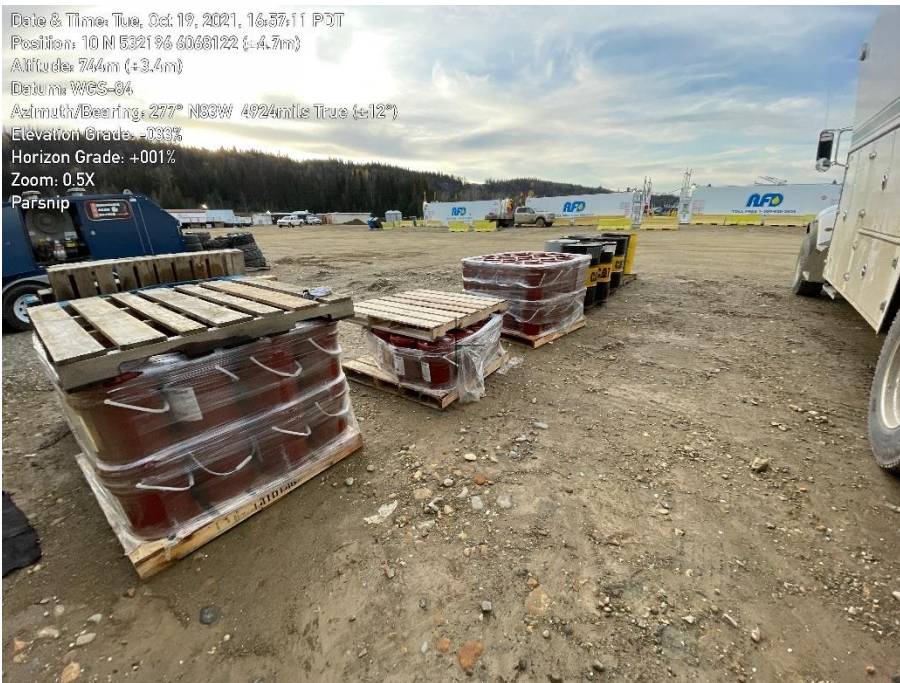
- No secondary containment for bulk chemical liquid products such as hydraulic oil, antifreeze and motor oil.

Photo 27. Bulk chemical liquids stored without secondary containment- Parsnip MUS.

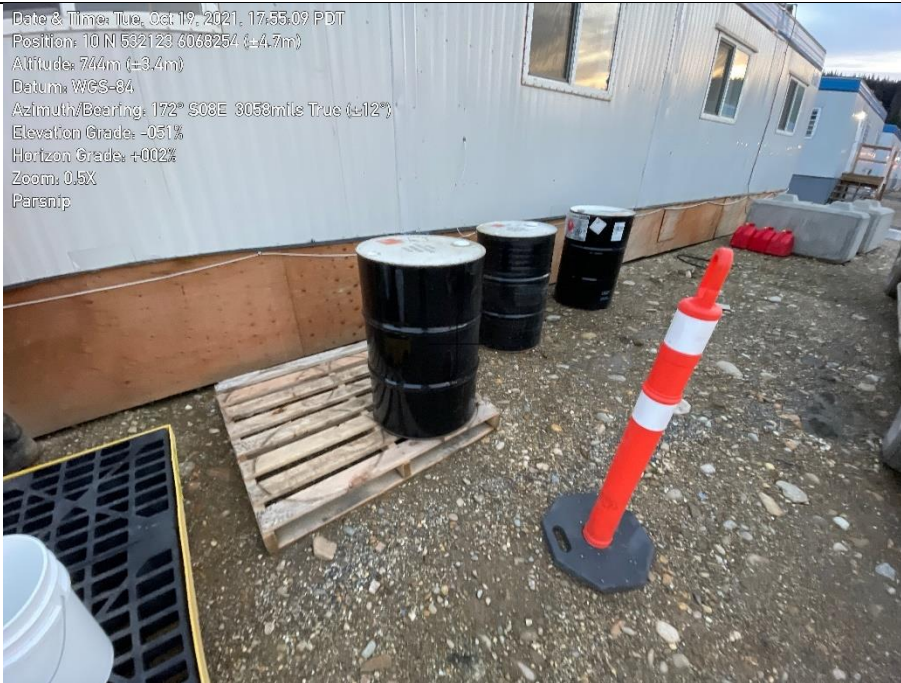
Photo 28. Bulk chemical liquids stored without secondary containment – Parsnip MUS.

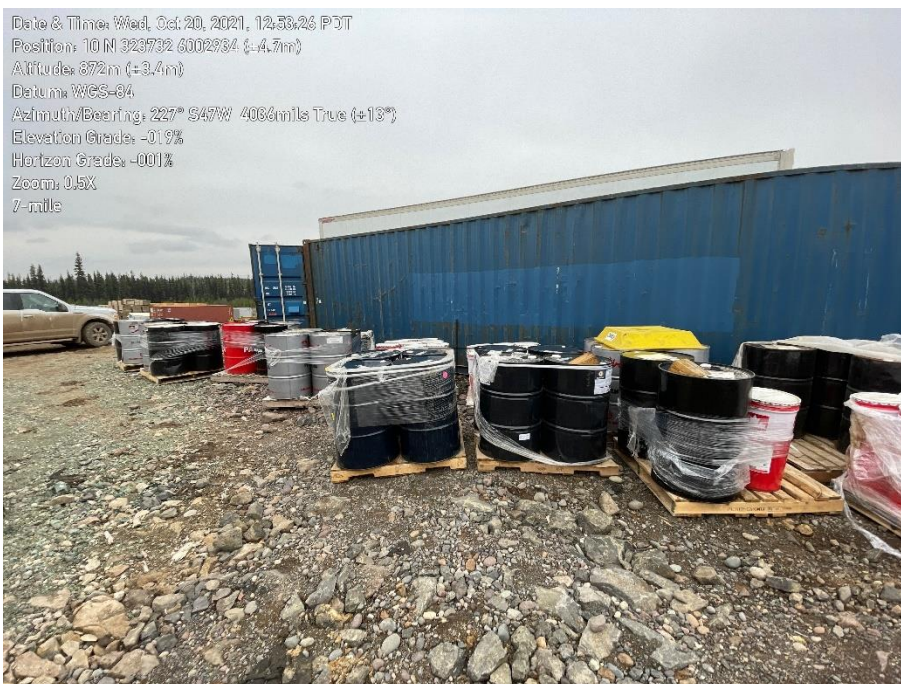
- No secondary containment for bulk chemical liquid products such as hydraulic oil and motor oil.

Photo 29. Bulk chemical liquids stored without secondary containment- 7-mile laydown.

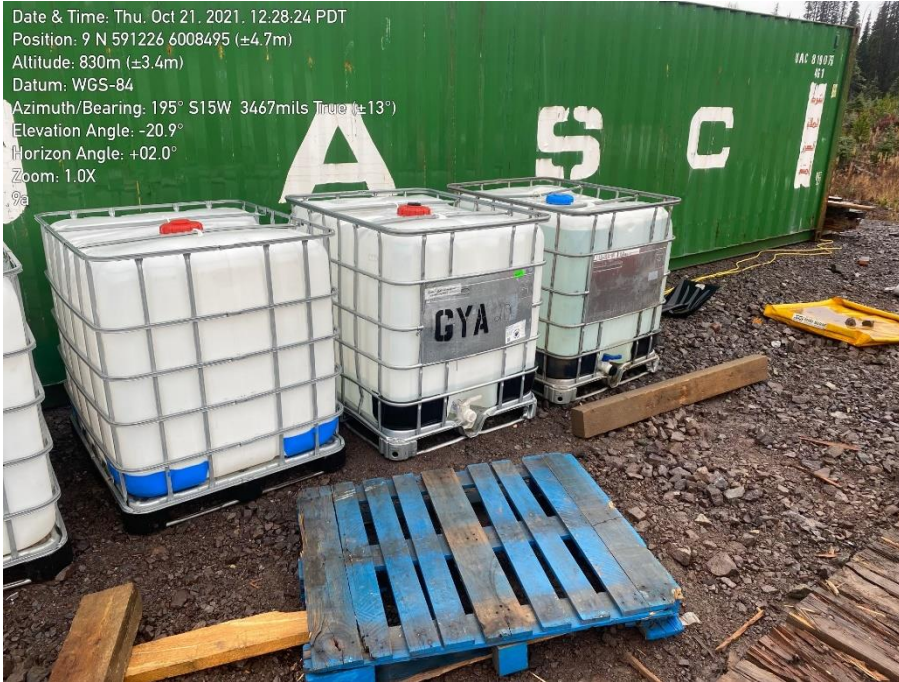
- No secondary containment beneath bulk chemical liquids.

Photo 30. Unlabelled bulk containers without secondary containment beneath.

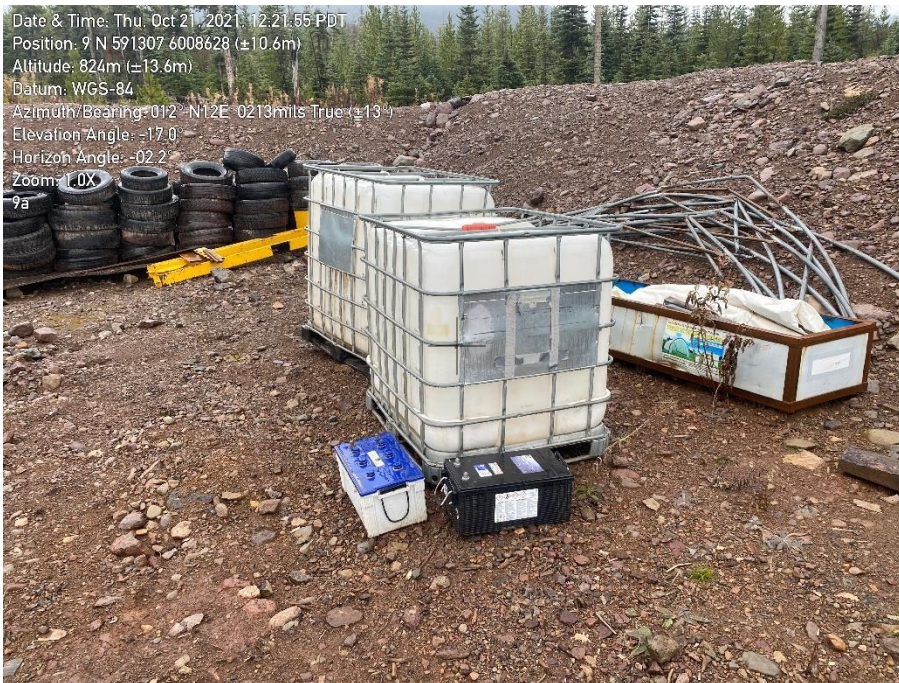
Photo 31. Batteries stored directly on ground.

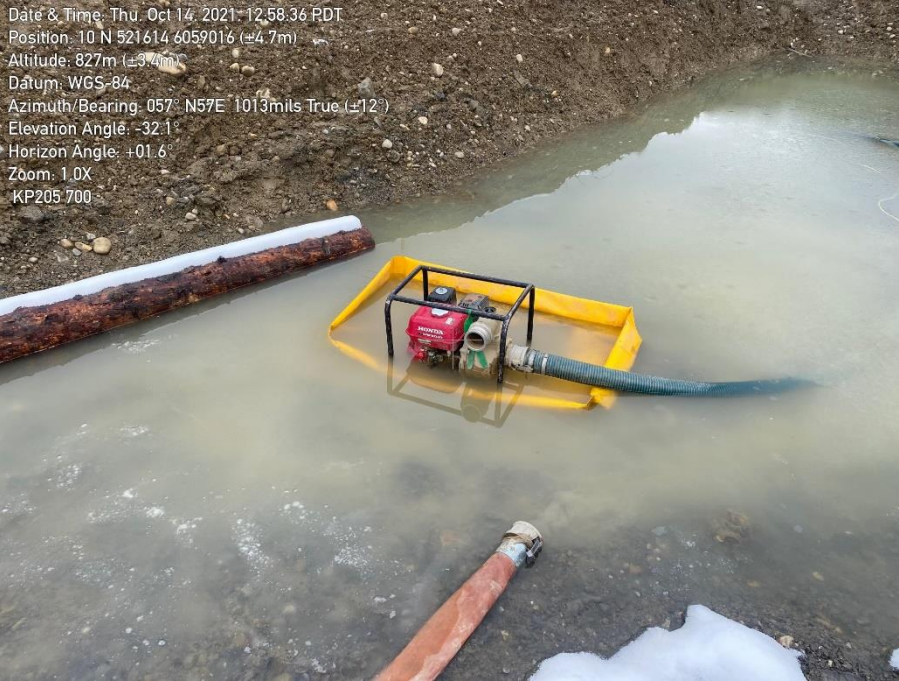
Photo 32. KP205+700. Pump and containment submerged in water.

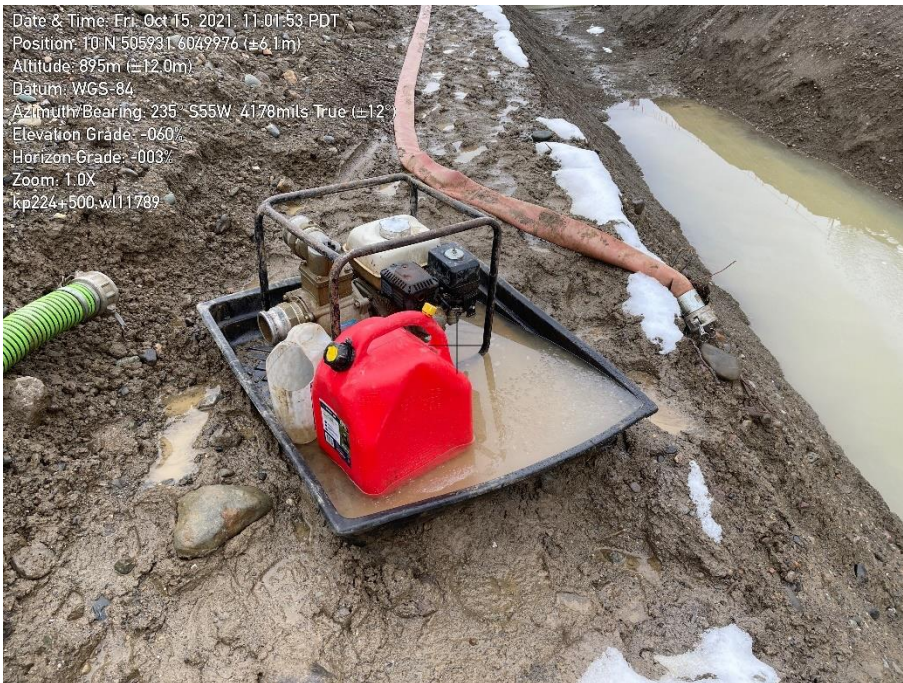
Photo 33. KP224+500. Secondary containment beneath pump at capacity with water.

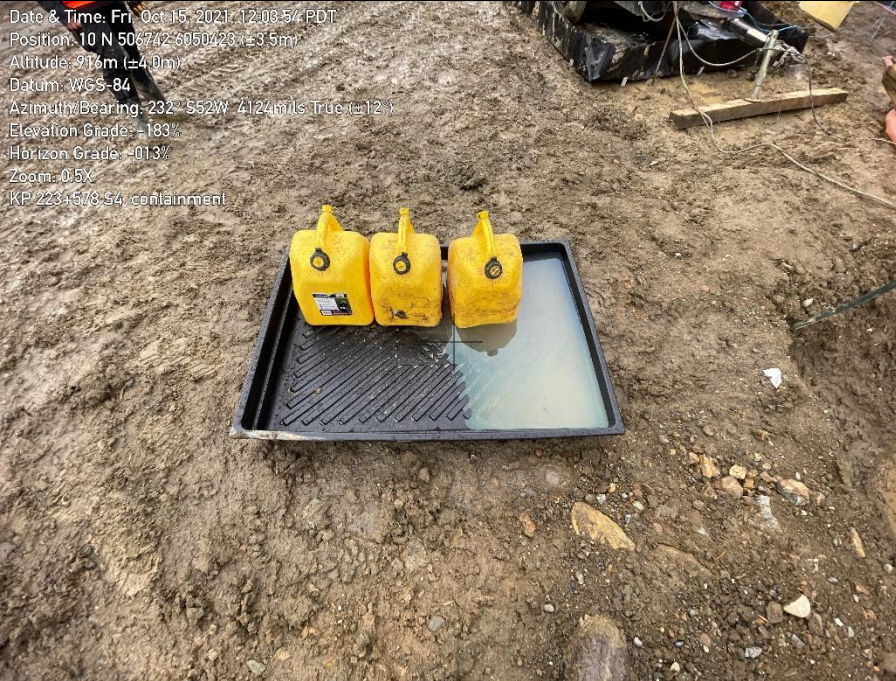
Photo 34. KP223+578. Diesel jerry cans within secondary containment.
