Project Name	Coastal Gaslink Pipeline Project	Inspection Status	Final
EA Certificate #	E14-03	Inspection No.	IR2021-027
Project Status	Certified	Inspection Start	2021-10-14
Sector	Energy	UTM	10U 533697 E 6071620 N
Trigger	Planned Inspection	Inspection Type	Field
Project Description	The Coastal GasLink Pipeline Project (Project) is an approximately 650 kilometer (km) long natural gas pipeline connecting facilities in northeast British Columbia (BC) to the LNG Canada facility near Kitimat.		
Location Description	The Project is near Groundbirch (40 km west of Dawson Creek) in northeast BC to the LNG Canada facility near Kitimat. This inspection covered work being carried out in Sections 1, 2 3, 4, 6, 7 and eastern 8 of the Project.		
Inspection Summary	<p>From October 14 to October 21, 2021 Environmental Assessment Office (EAO) Director of Compliance and Enforcement Chris PARKS and Senior Compliance and Enforcement Officer Clayton SMITH (collectively EAO C&E) inspected the Project against requirements of the Environmental Assessment Certificate (EAC) #E14-03 (Appendix 1).</p> <p>The Project was in Construction at the time of inspection. Project areas inspected include Sections 1, 2, 3

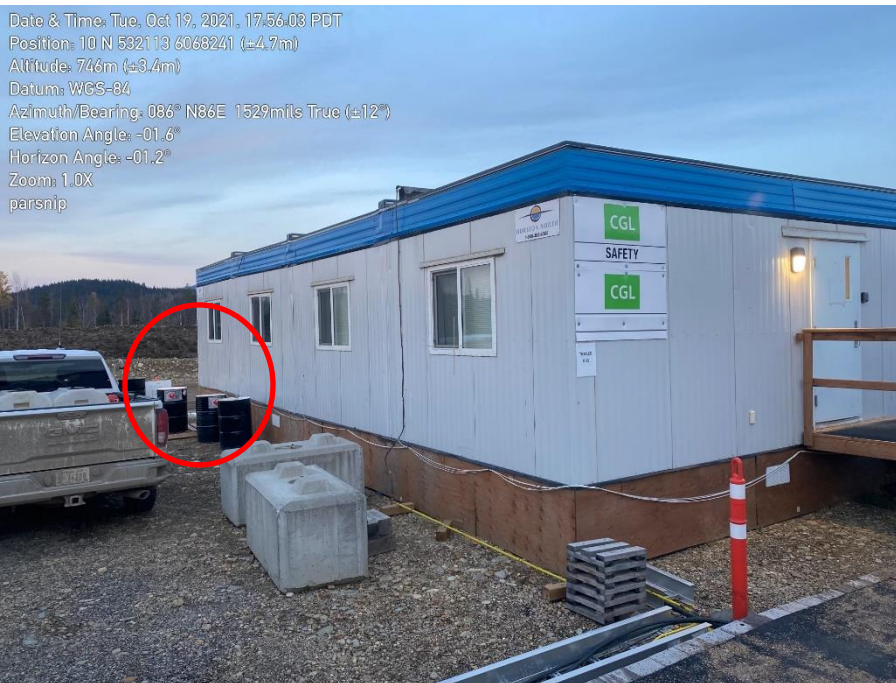
Photo 35. Overview of storage area, near site offices. Note barrels without secondary containment in place (Requirement 4, above).

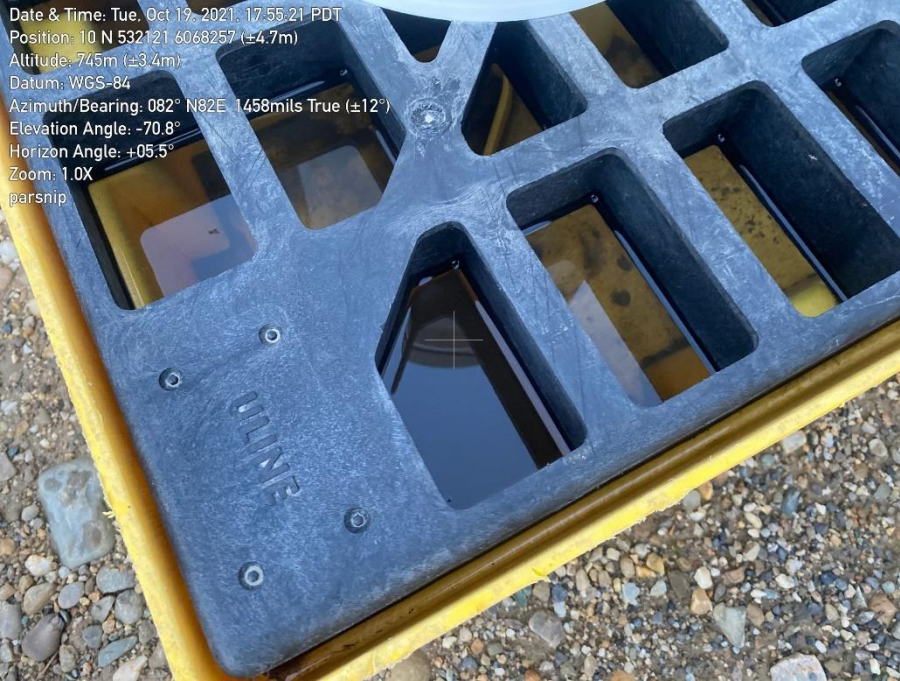
- Secondary containment beneath barrel containing methyl hydrate near capacity with rainwater.

Photo 36. Close up of spill tray seen in photo above. Spill tray near capacity with rainwater.

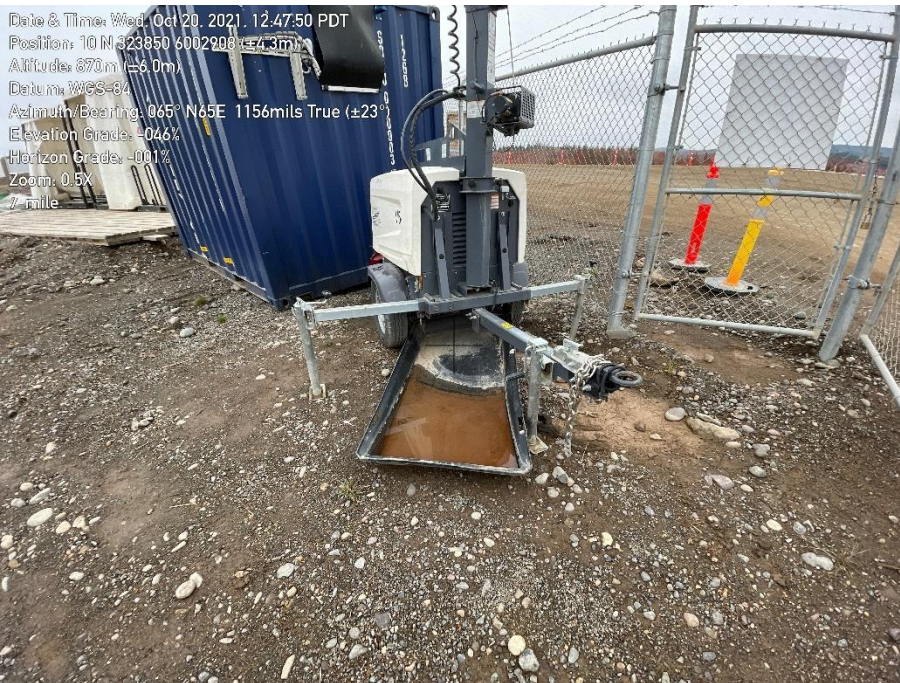
- Secondary containment beneath light plants and pumps at or near capacity with water.

Photo 37. Secondary containment on angle and at capacity with water.

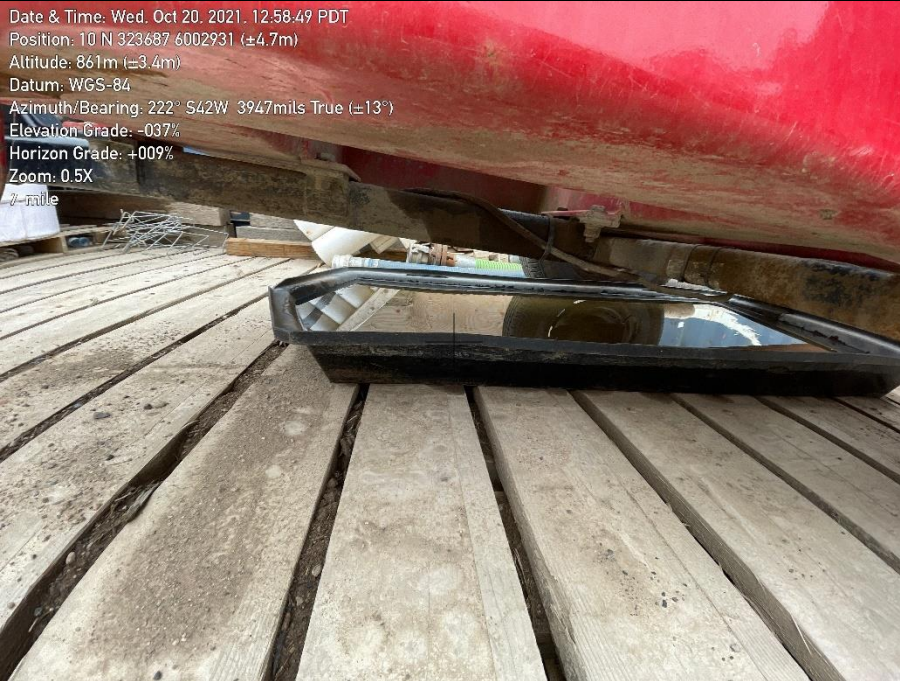
Photo 38. Secondary containment beneath pump at capacity with water.

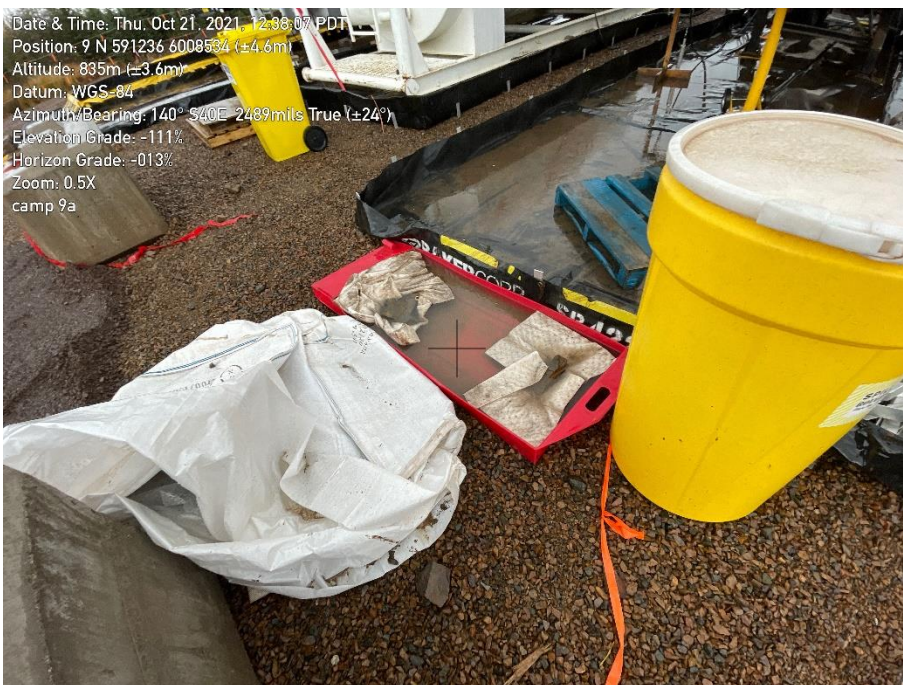
Photo 39. Secondary containment with used spill pads inside at capacity -MUS 9A.

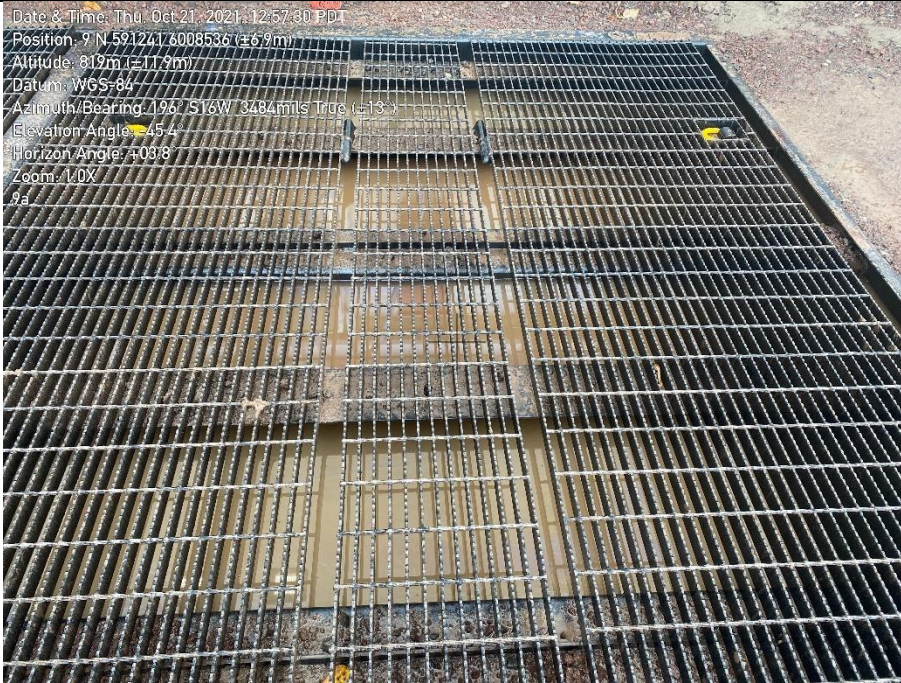
- Containment beneath vehicle parking area at fuel island at or near capacity with water.

Photo 40. Containment beneath vehicle parking area at fuel island near capacity – MUS 9A.

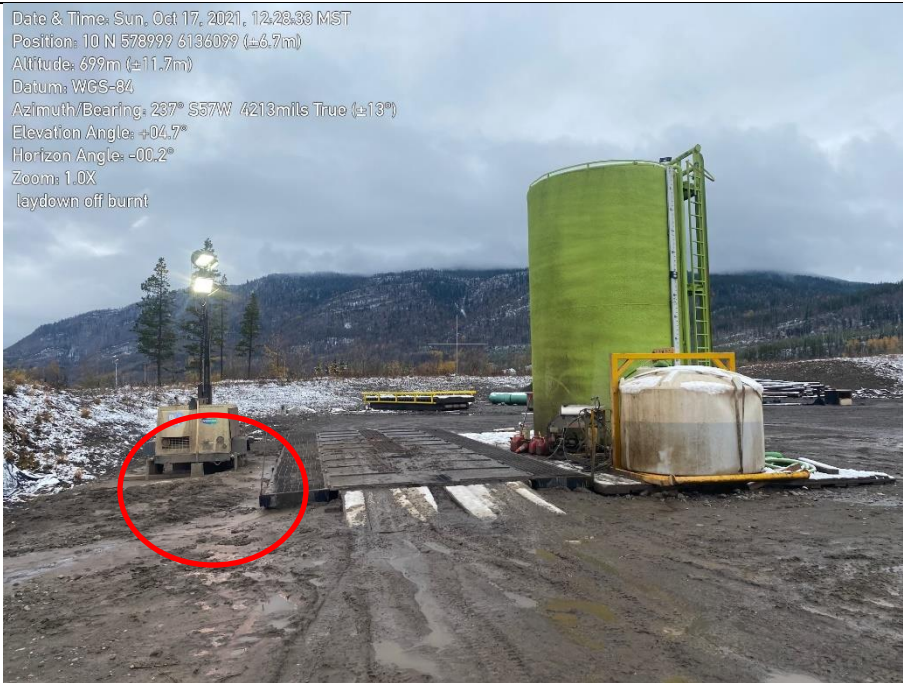
- Wash station at laydown 12 has grating for vehicles to park on and catch/contain the wash water. Catchment beneath wash station is full of hydrocarbon laden water. Water was observed leaving the catchment area and discharging to the ground outside the wash station.

Photo 41. Overview of wash station. Red circle indicates location where wash station is discharging hydrocarbon laden water to the environment.

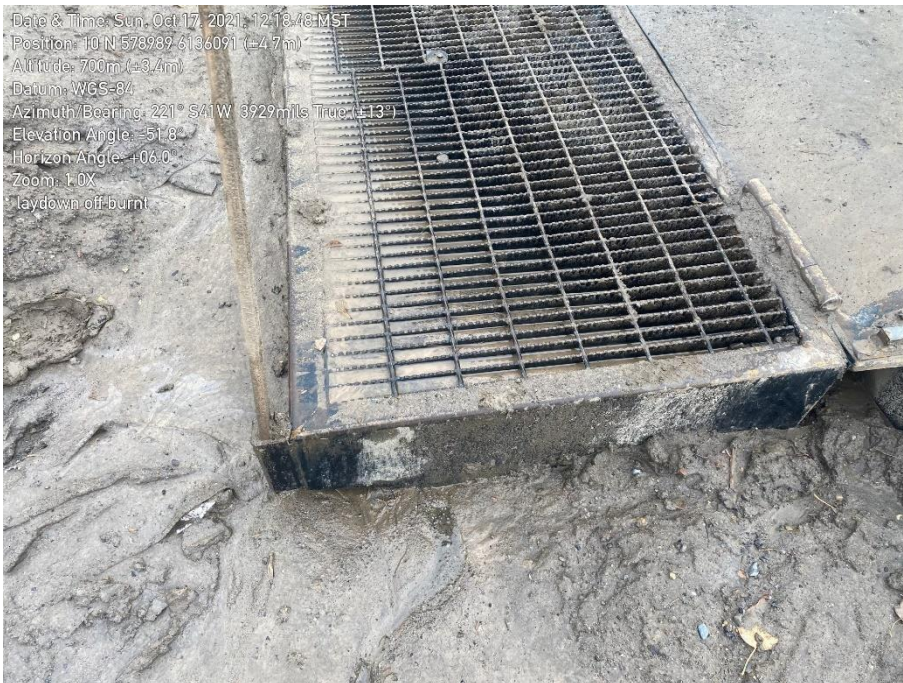
Photo 42. Close up of location in red circle in above photo where containment overtops.

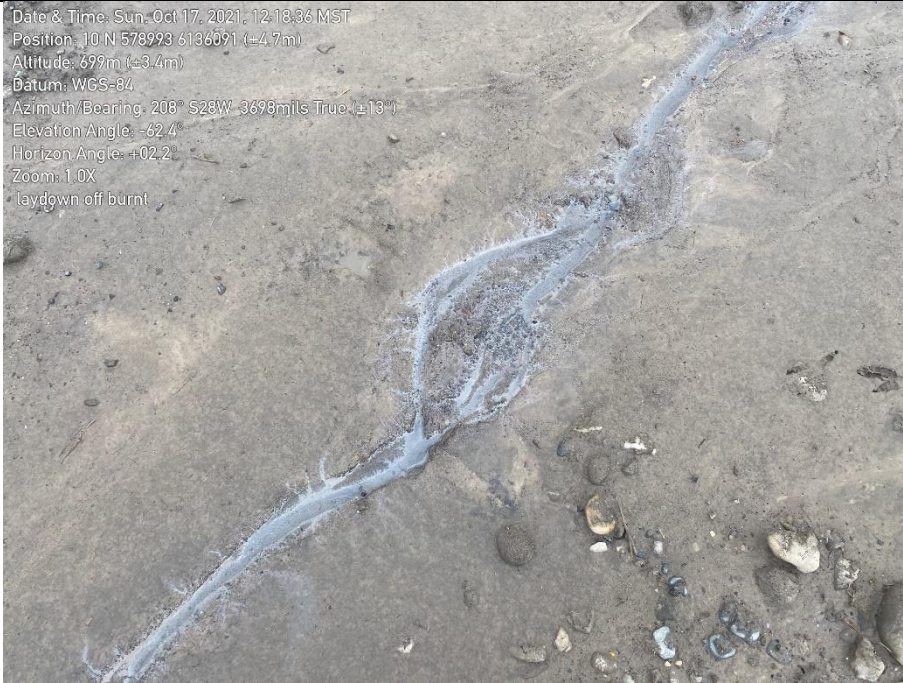
Photo 43. Visible hydrocarbon sheen from the wash station in the surrounding environment.

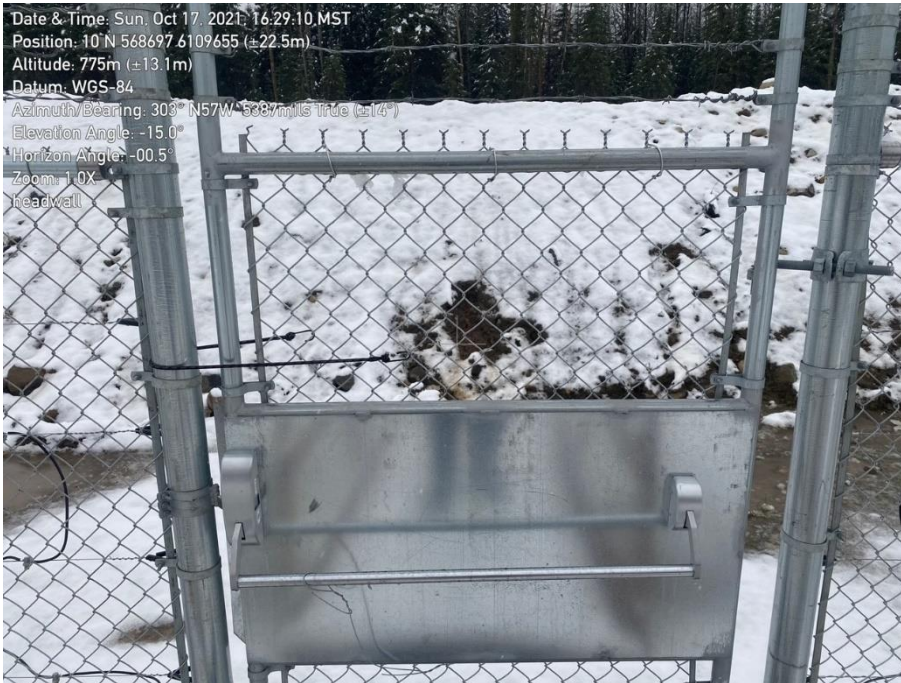
When inspecting the electric fence at the Headwall MUS the electric fence was found to be on and functional. However, EAO C&E noted that three out of the four man-gates around the MUS were secured closed using bungy

Photo 44. Example of man-gate secured closed using bungy cord – Headwall MUS.

On November 26, 2021 the Certificate Holder provided EAO C&E with a response to this inspection record (Appendix 11). In the response the Certificate Holder confirms that the bungy cords have been removed from the man-gates and replaced with latches to properly secure the gates.

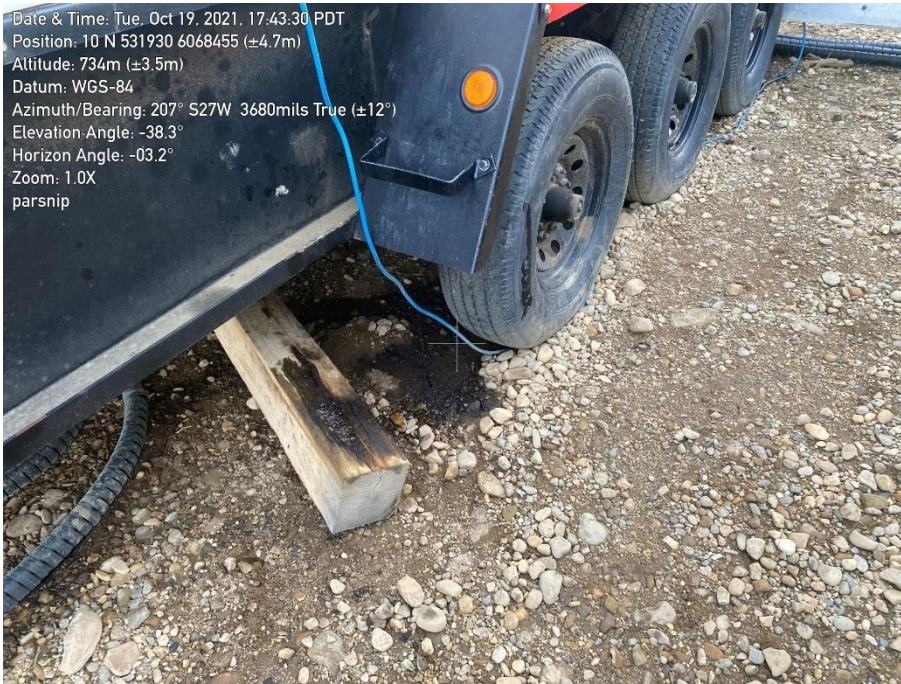
During inspection of the Parsnip MUS, EAO C&E observed a spill to ground beneath a generator located near the employee parking area. See below photos.

Photo 45. Leak to ground beneath active generator at Parsnip MUS.

On November 26, 2021 the Certificate Holder provided EAO C&E with a response to this inspection record (Appendix 11). In the response the Certificate Holder confirms that the spill to ground at the Parsnip MUS has been cleaned up and repairs made to the generator to prevent further leaks.

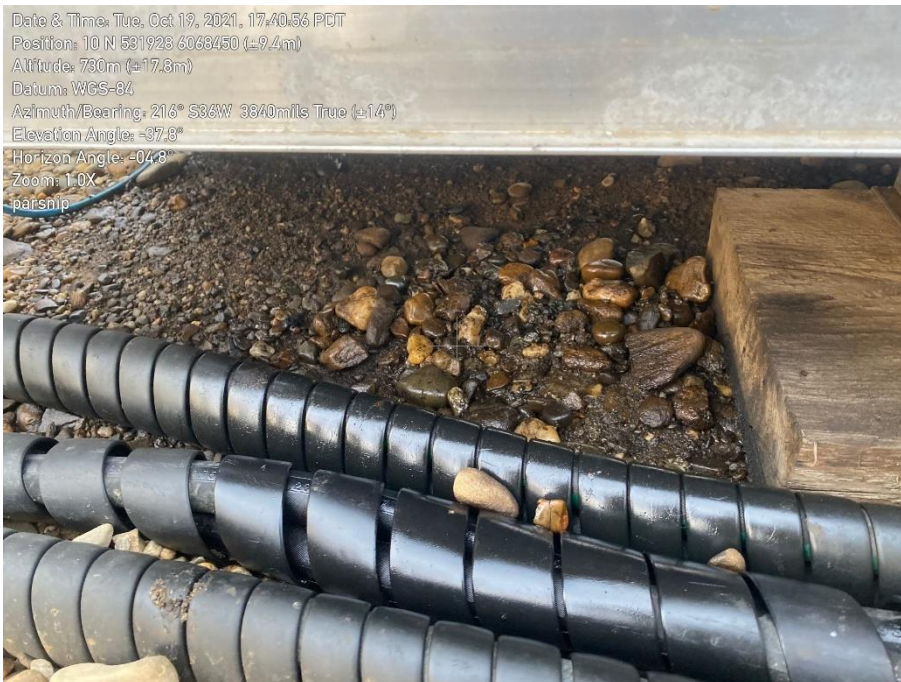
Photo 46. Close-up of an active leak to ground beneath an active generator at the Parsnip MUS.
